# ***East Brook Watershed Assessment***

## ***Warren County Soil and Water Conservation District***

**February 2008**

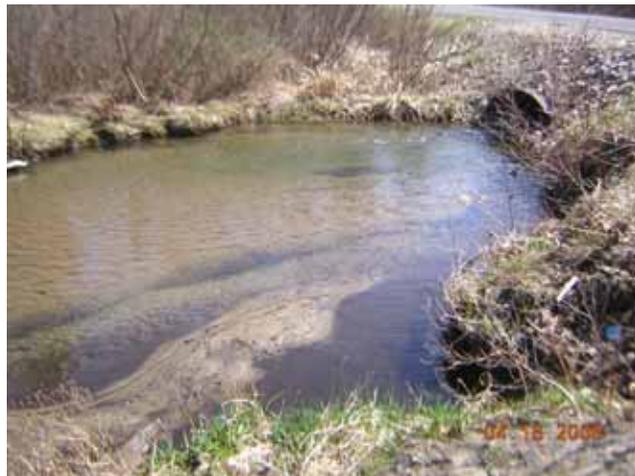
*Photo 2: Sediment deposit near Sun Valley Road.*

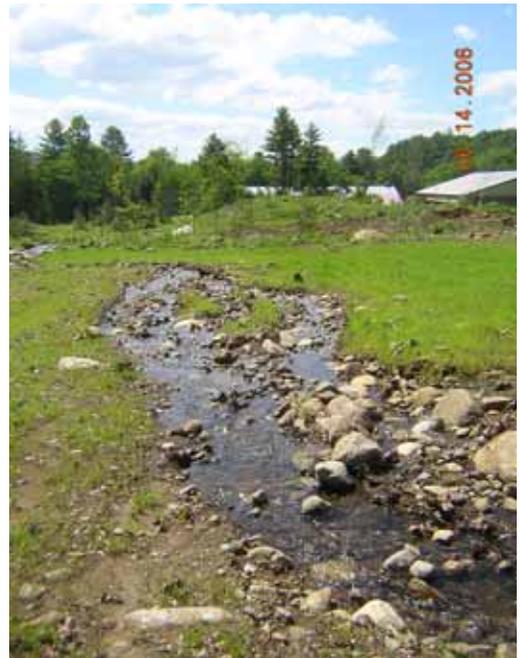
*Photo 5: Stream with vegetative buffer removed*

During the stream assessment District staff noted that the majority of the stream banks appeared stable and vegetated. However, there were portions in the more developed areas of the watershed that would benefit from larger vegetation such as trees and shrubs. There were also several locations where sandy deposits were noticeable along portions of the stream, indicative of erosion. In areas of development and road corridors, care should be taken to preserve greater vegetative buffers along the stream to filter the water before it enters the stream. Streamside landowners should be encouraged to minimize the amount of open lawn which abuts the stream, replacing these lawns with native vegetation which would provide both a water quality filter and perhaps some shading of this stream. Environmental groups such as the Lake George Association have considerable information regarding homeowners and buffers using native vegetation.

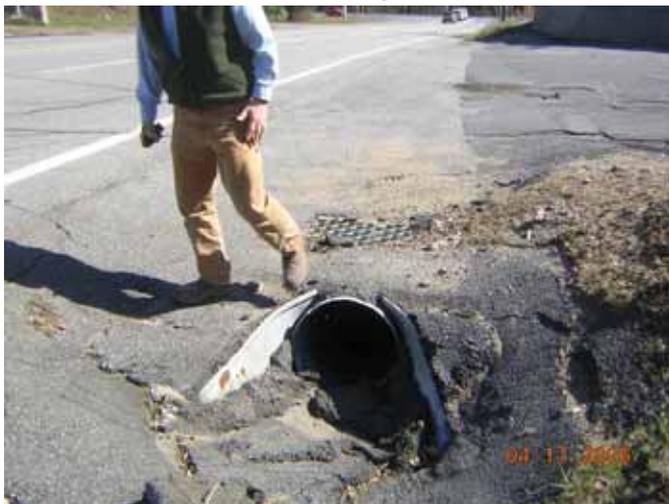
*Photo 11: Sediment collecting near drop inlet on NYS Route 9N.*

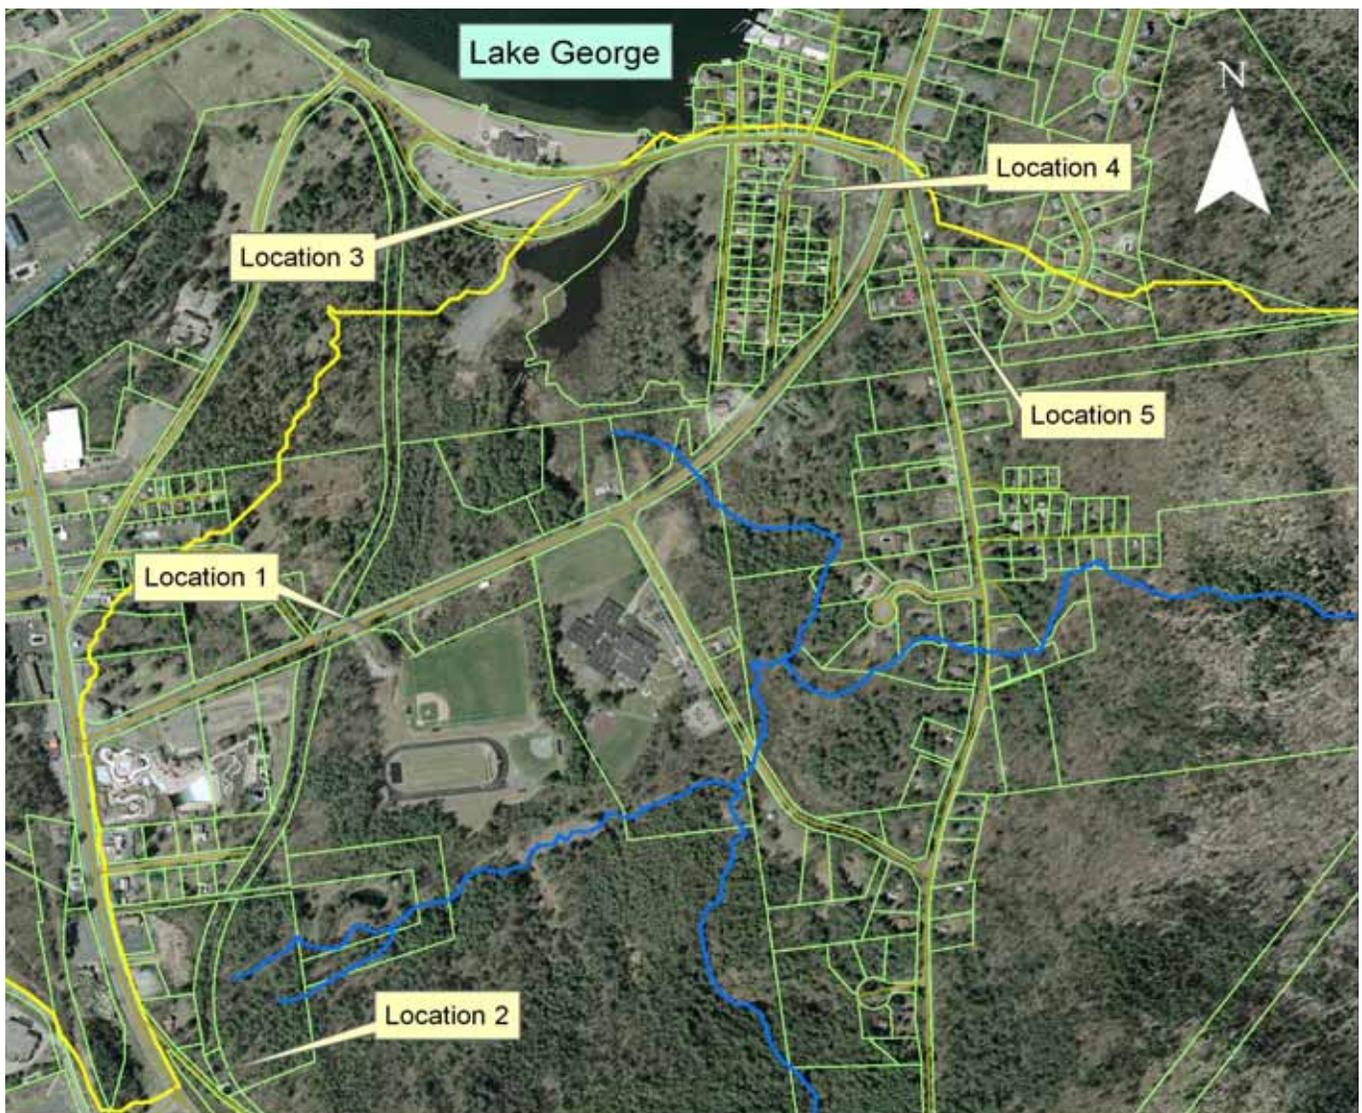
Figure 8: Sites proposed for restoration or retrofitting activities

Soil and Water Conservation District staff walked the entire East Brook watershed including the populated areas of each tributary, the mainstem and the road network. Photographs were taken to document areas of excessive erosion or aggradation along the stream bed or banks and stormwater drainage and sedimentation were documented within the road network. A few areas were noted as critical due to the proximity and drainage to the stream. These locations are shown in Figure 8, and are expanded upon below.

Stormwater flows along NYS Route 9L beginning to the east where it intersects NYS Route 9. The stormwater flows down the roadside ditch for approximately ½ mile which ultimately outlets into East Brook near Green Pond (location #1 on Figure 8). At this site, a stormwater basin or small constructed wetland could be installed to reduce pollutant loading to East Brook. By having the runoff drain into either a surface or subsurface structure, water would infiltrate into the ground and be treated by the soil. Sediment would be left in the basin, which could be maintained by the Town of Lake George Highway Department on an annual basis. The out of pocket cost of this could be minimal, as it could be able to be done with Town equipment and Town labor. Measures such as this are simple and cost effective yet can have a tremendous impact on water quality in terms of sediment load to the stream.

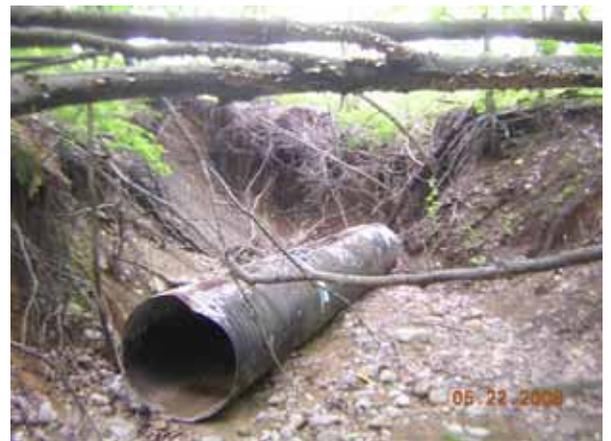
### **2. Northway Exit 21 (photo 12)**

The Exit 21 outfall collects runoff from a large developed area including ¼ mile of the north and southbound lanes of Interstate 87. The drainage channel that this area feeds was noted as being scoured and deeply incised. The soils in this area are composed of a sandy silt mixture with clay; inclusions which are highly susceptible to erosion. As evidenced in the photograph, water velocities at this location are extreme and have carried much sediment downstream and caused the outlet culvert pipe to fail.

*Photo 12: Erosion at the Exit 21 tributary (looking upstream)*

The culvert should be fixed by attaching an additional section of pipe and placing medium to medium heavy NYS DOT stone at the outlet area to break up the kinetic energy of the flow. There is also an opportunity to redirect flow away from the clay channel and allow for more infiltration. Cost Estimate: \$10,000-\$20,000

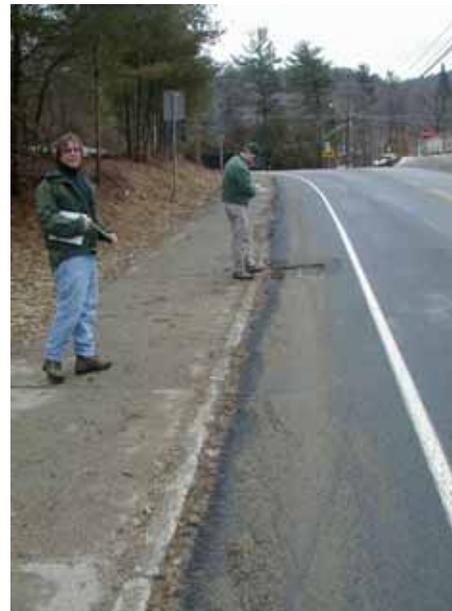
*Photo 13: Beach Road showing sand buildup from winter sanding operations*

In 2010, Beach Road is scheduled for reconstruction by Warren County. The county is addressing flooding concerns on the roadway, and is open to addressing water quality issues as well. There are many opportunities for stormwater structures including catch basins and infiltration units along portions of the road, and these will be looked into by the county and the Warren County SWCD during the planning and engineering process for the Beach Road reconstruction effort.

Cost Estimate: \$25,000-\$50,000

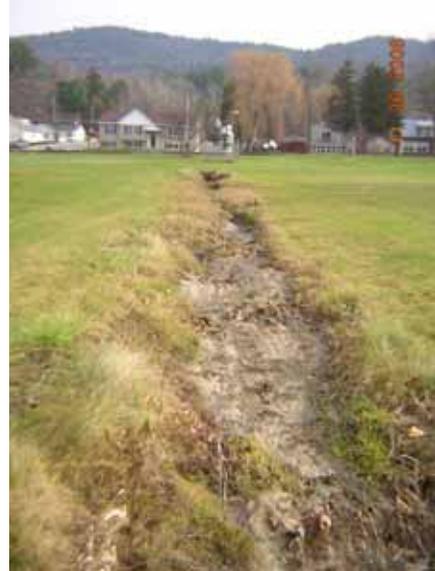
The drainage channel between Beatty Road and Cedar Lane is in need of protection as well. This unnamed tributary to East Brook is scoured between Beatty Road and Cedar Lane, as can be seen in the photos. There is a lack of deep rooted vegetation such as trees and shrubs along this portion of the stream. There are sand deposits present in the channel and it does not appear to be stable or holding its shape along the banks and stream bottom.

*Photo 14: Downstream of Cedar Lane*

The channel below should be lined with stone and the banks graded back if possible and revegetated with trees and shrubs such as willow, silky dogwood or red maple. This is a narrow work area which poses a challenge. However if this is completed this would likely reduce a large sediment source to East Brook.
