French Mountain Roadway – Environmental Assessment

Dave Wick, District Manager
Certified Professional in Erosion and Sediment Control

May 12, 2008

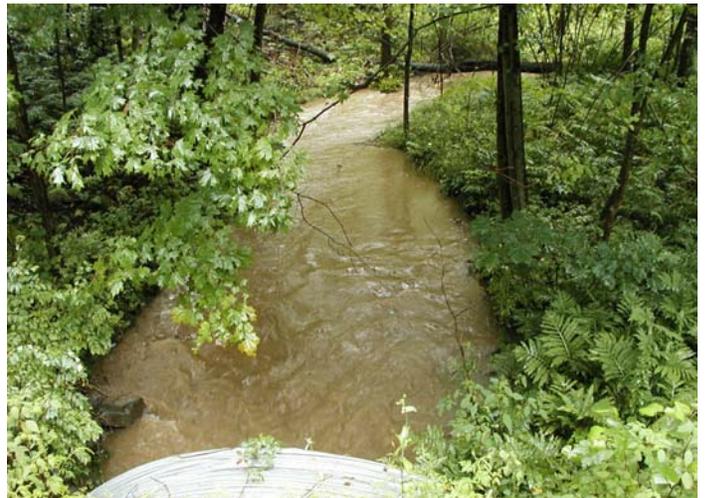
In the picture noted to the right, Bear Pond Brook had a substantial water quality standards contravention in 2004 resulting from road construction activities on French Mountain. These same conditions were noted on the two other smaller regulated streams on the mountain. High levels of turbidity (sediment suspended in the water)

Turbidity (sediment suspended in the water) is shown in Bear Pond Brook (classified trout stream) in 2004, resulting from road construction activities on French Mountain. Photo: NYS DEC - 2004

are evidenced, and lasted over the period of days or weeks. Similar streams adjacent to this property were reviewed by NYS DEC staff to contrast conditions, and those streams were flowing clear at the time.

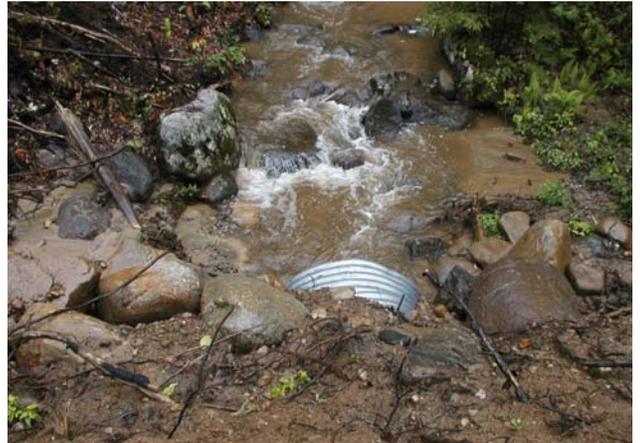
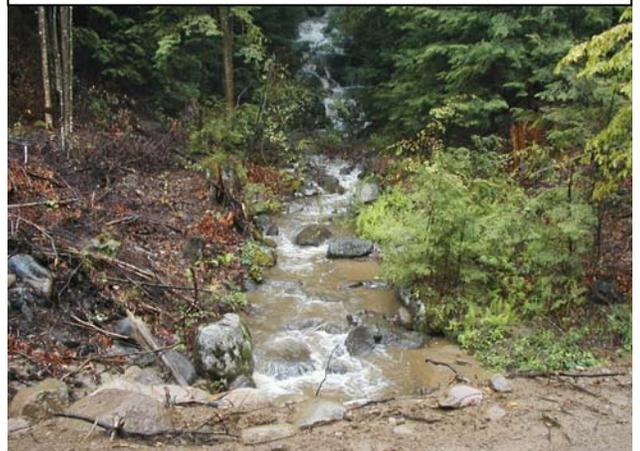
Bear Pond Brook is a spawning trout stream, which was heavily impacted by sedimentation from road construction activities on the mountain. From the pictures gathered by the NYS DEC during multiple visits, there was significant sedimentation of Bear Pond Brook and at least one smaller tributary, both classified as "AA(T)" which is the highest water quality classification for a stream. The "T" denotes that the stream is a trout stream by DEC standards.

*Sand and silt washed into streams from road erosion on French Mountain. These streams are NYS DEC classified trout streams. Sediment is shown here embedded in the cobble rock and gravel in the streams.
Photos: NYS DEC - 2004*

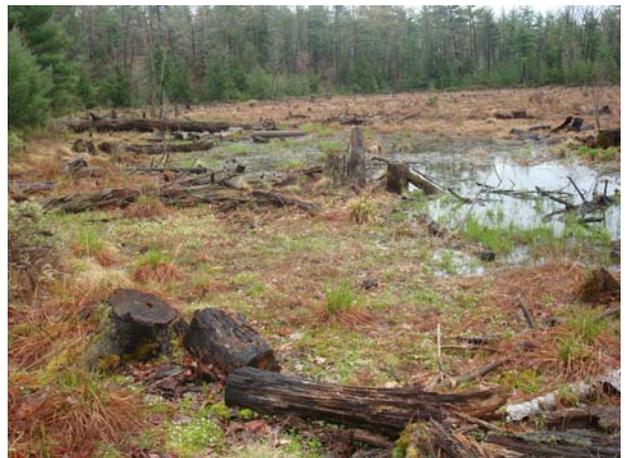
French Mountain runs adjacent to a few locations where wetland conditions occur, and some road material sediment was observed having entered into wetland areas. These

sedimentation impacts were seen as minimal, and not having a large impact on any wetland ecosystem or complex.

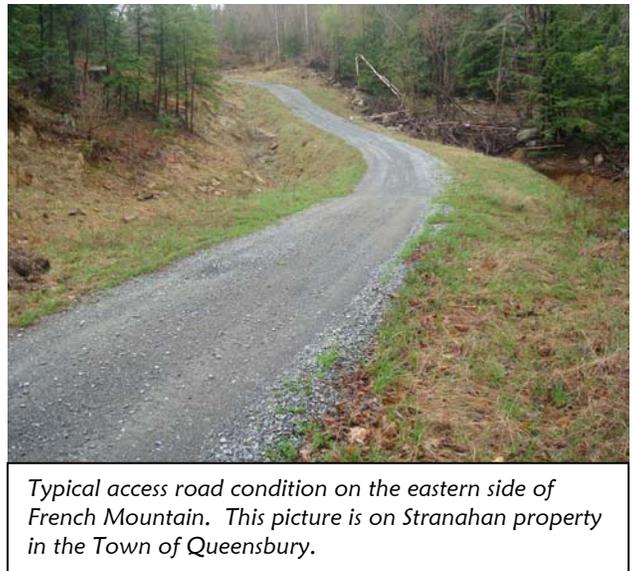
1. This section of road is in very stable condition, with an average surface width of ten to twelve feet. There are some short sections of this road where the gravel has washed and rutted (average depth of 2-10 inches). This is a routine maintenance issue and should be addressed in the near term to avoid larger washouts.
2. The surface of the road is covered in crushed stone, which has been graded and compacted. This helps to minimize erosion of the roadway and is recommended for erosion control purposes.
3. The shoulders of the roadway are generally well vegetated, and there is little evidence of current or ongoing erosion.

4. The average forest canopy opening for the roadway ranges from 30' up to over 100'. These widths are largely based upon the amount of area required to obtain fill to construct the road.
5. From a natural resources perspective, this roadway is seen to be in good working condition for a long-term use access road.

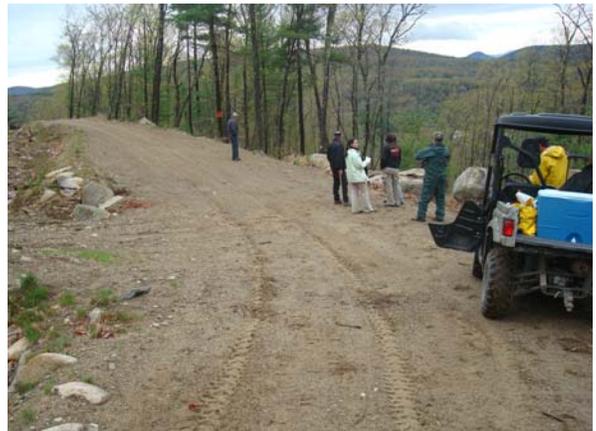
West side of French Mountain, at intersection of two roadways. Much of this road is sand with little vegetation on the shoulders.

2. The road surface on much of this side of the mountain remains in a compacted sand condition, which is more erosive than the compacted stone on the east side. There is more evidence of rutting of this surface as well, which will lead to additional future erosion issues.

3. There is little differentiation between the road surface and any shoulder areas, as there is a lack of vegetation on many of the shoulders on the west side. The side slopes of the sand shoulders are unconsolidated and unstable, which leads to sedimentation of the roadside drainage system. This can be a problem in some areas where the ditches drain to streams and wetlands.

4. The width of the road on the west side in many areas is significantly larger than would be justified for an access road, and should be narrowed to ten feet with vegetated shoulders as seen on the east side. Mr. Macchio verbally agreed during the site tour that a ten foot road surface would suit his needs.

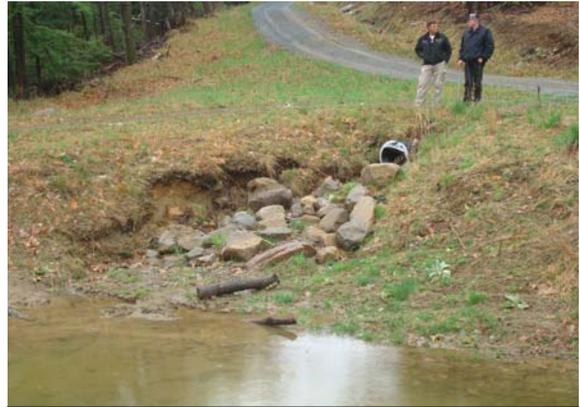
Inlet to a retention basin which needs to be re-shaped and stabilized. This basin is full and is in need of cleanout for it to function as designed.

It is our recommendation that work be conducted immediately to maintain the integrity of these installed drainage systems. This work includes the following:

1. Excavation of sediments out of the retention basins.
2. Stabilizing all inlets, outlets, and side slopes of these basins with vegetation or rock.
3. Seeding of all vegetated ditches where there is less than a 75% cover of vegetation, or rock lining of ditches where appropriate.
4. Re-shape basins which have

excessive side slopes (i.e. steeper than 1.5 horizontal to 1.0 vertical) and stabilize as appropriate.

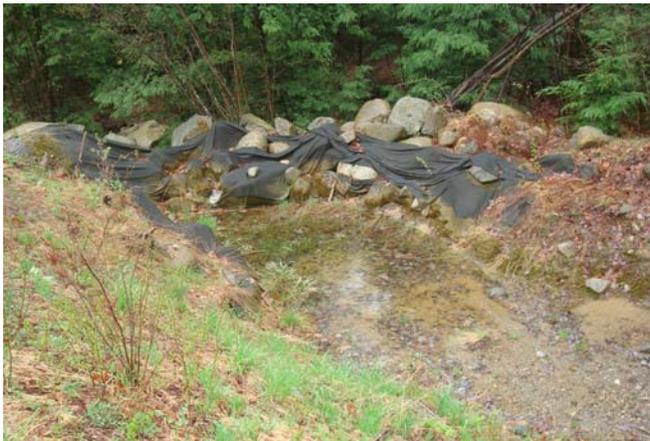
Retention pond in need of reshaping and stabilization.
