MS4 Village of Lake George

Illicit Discharge Report

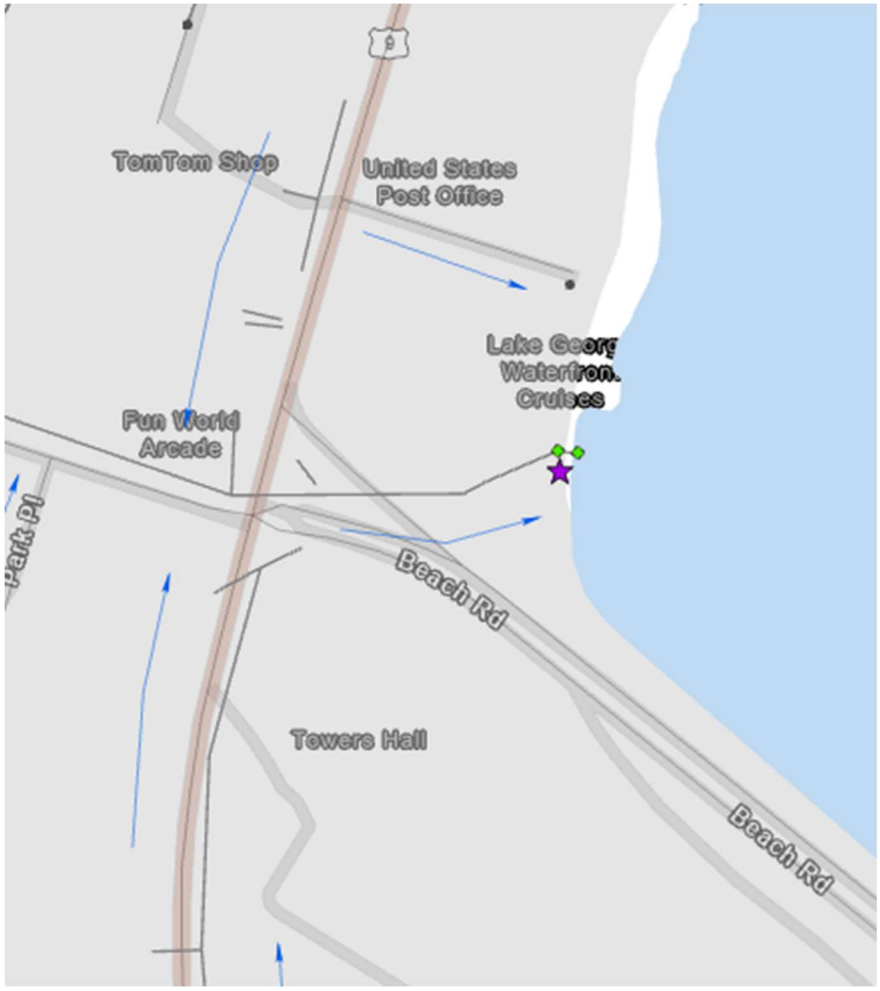
b) Location of the illicit discharge: Near the sheriffs dock outfall, behind the visitor center near the Route 9/Beach Road intersection

c) Nature of the illicit discharge: Unknown- Small oil sheen south of the outfall in Lake George.

- Small oil sheen along the edge of the melting ice on Lake George
- The winter carnival is very busy in this area with cars, motorcycles, snowmobiles and other vehicles parked all around the visitor center and accessing the ice.

- One drop inlet near the back on the visitor center had a small amount of pink snow near it, but the substance could not be identified.
- No enforcement taken as the source could not be identified.

d) Follow up actions taken or needed (including response times): The Village of Lake George DPW is going to continue to monitor the location daily from March 9-13. During the follow up inspections, DPW reported that the sheen dissipated and has not reappeared.
